Good as New, Back to Work!

Situation

An explosion occurred at a California oilfield pumping station where the four pumps were fully immersed in a fire ball. All four pumps were disassembled to assess the extent of the damage. Several mechanical deficiencies were identified during the teardown inspection. The pumps were deemed repairable.

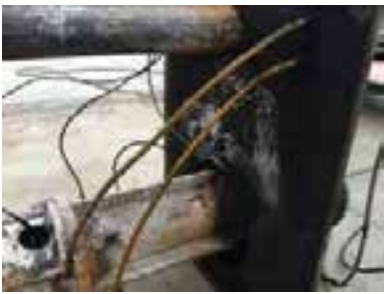
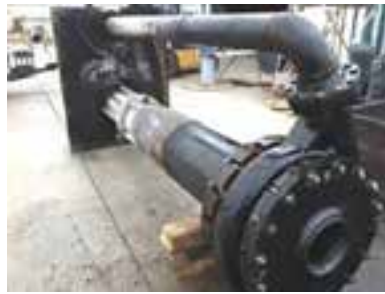
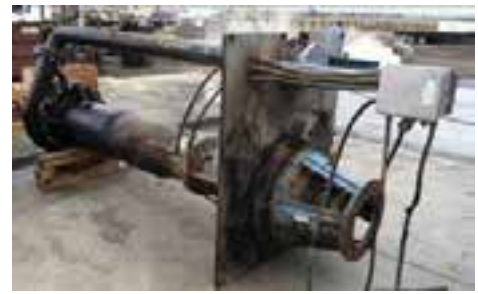
Extensive Fire Damage...

The pumps were obviously damaged from the explosion and fire but were also vintage and would need upgrades in monitoring and controls. Energy Link rebuilt the 4 pumps to OEM specifications and then put back into service.

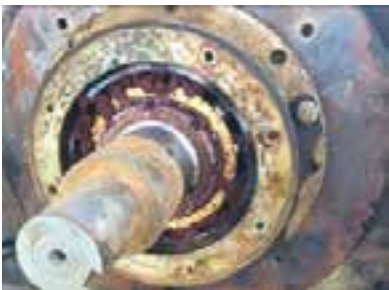
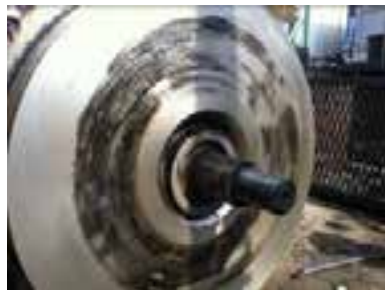
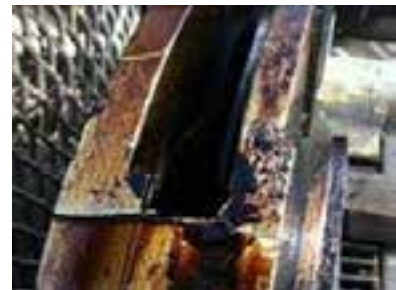
Mechanical Damage...

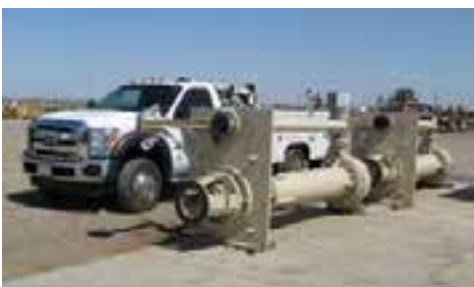
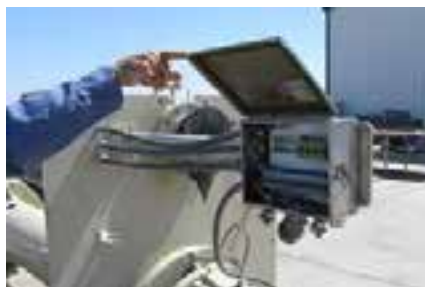
Good as new and ready to get back to work:
